The Future of the Champlain Bridge

Prepared for:
**The Jacques Cartier and
Champlain Bridges Incorporated**

March 22, 2011

Delcan was retained in August 2010 by The Jacques Cartier and Champlain Bridges Incorporated to carry out a Structural Health Assessment Study of the Champlain Bridge.

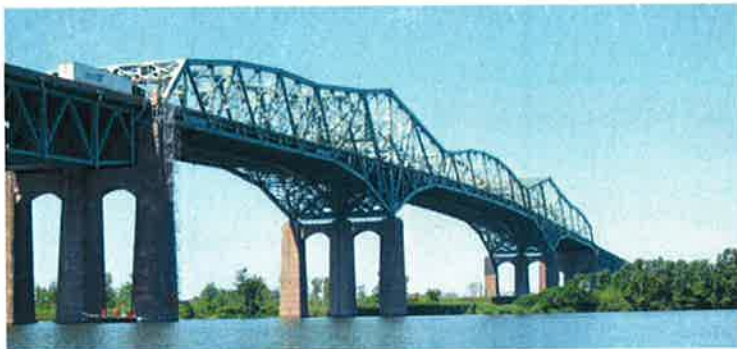
Figure 1 - The Cantilever-Type Steel Truss Bridge

- The structural steel superstructures (Section 6) are in relatively good condition. While these structures provide some structural redundancy, they are not considered to have a large excess of live-load carrying capacity. The orthotropic steel deck on the main structure has however improved the live-load carrying capacity as well as its rigidity and durability.

The various elements of this major bridge crossing vary in condition from 'good' to 'deficient'. There are significant portions and elements of the bridge which are in a condition that might be described as 'satisfactory' in the context of its service life to date of 48 years. Amongst these, one finds the structural steel main span, the structural steel deck trusses, the orthotropic steel deck on the main span (which is about 17 years old), and portions of the reinforced transversely post-tensioned deck/girder system which comprises Sections 5 and 7. These are significant elements and a significant percentage of the total bridge structure and hence an early impression of the bridge might be that it could be rehabilitated if appropriate measures could be found to deal with the deterioration which exists in the other elements of the bridge while, at the same time, maintaining traffic in service to a satisfactory degree. The structural steel in the main span structure, for example, weighs some 11,000 tons and a very considerable investment has been made by Canada in its original construction and in maintaining it since its entry into service, in addition to a major rehabilitation effort involved in replacing the original reinforced concrete deck with an orthotropic steel deck with consequent significant benefits to this bridge section.
